Landslides density map of S. Miguel Island, Azores archipelago

P. Valadão¹, J. L. Gaspar¹, G. Queiroz¹, and T. Ferreira¹

¹Centro de Vulcanologia e Avaliação de Riscos Geológicos, Departamento de Geociências, Universidade dos Açores, Rua Mãe de Deus, 9501-801 Ponta Delgada, Portugal

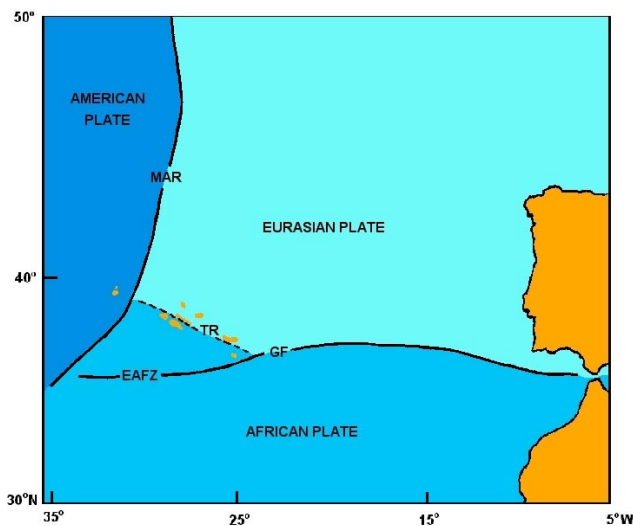
Fig. 2. Main tectonic structures that can be defined in the area of the Azores Triple Junction. MAR (Mid-Atlantic Ridge); EAFZ (East Azores Fracture Zone); TR (Terceira Rift) (adapted from: Gaspar et al., 1999).

East Azores Fracture Zone, that extends E-W from the Mid-Atlantic Ridge to Gibraltar; and (3) the Terceira Rift, which trends NW-SE from the Mid-Atlantic Ridge to N of Santa Maria Island. Several authors have studied the Azores Triple Junction and different geodynamic models have been proposed (Madeira and Ribeiro, 1990). The structural behaviour of the Terceira Rift, including the WNW-ESE Faial-Pico and S. Jorge fractures, is still a controversial issue (Fig. 2).

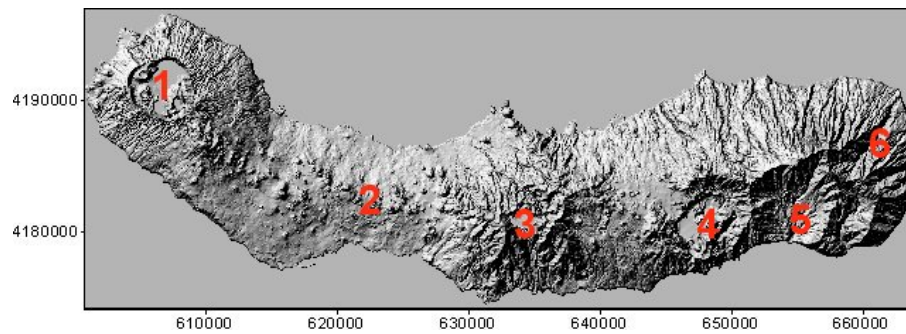
Fig. 3. Main morphological provinces on S. Miguel Island: (1) Sete Cidades Volcano, (2) Volcanic System of Picos Region, (3) Fogo Volcano, (4) Furnas Volcano, (5) Povoação Volcano and (6) Nordeste Volcanic Complex.

S. Miguel is located at the eastern end of the Terceira Rift and is marked by NW-SE, NE-SW and WNW-ESE tectonic features. E-W fault trends also occur and have been interpreted as reflecting deep oceanic structures (Queiroz, 1997). The distribution of volcanic vents on the island is strongly related to tectonics, with active trachytic stratovolcanoes located at the intersection of the main faults' systems, whereas cinder cones form impressive basaltic chains among the former major volcanic structures (Fig. 3).

On the other hand, the volcanic system of the Picos Region shows the lowest concentration of landslide events. This is due to the fact that this area is mainly built up by recent basaltic lava flows, with minor interbedded scoria deposits, presenting gentle slopes and just a few immature valleys.

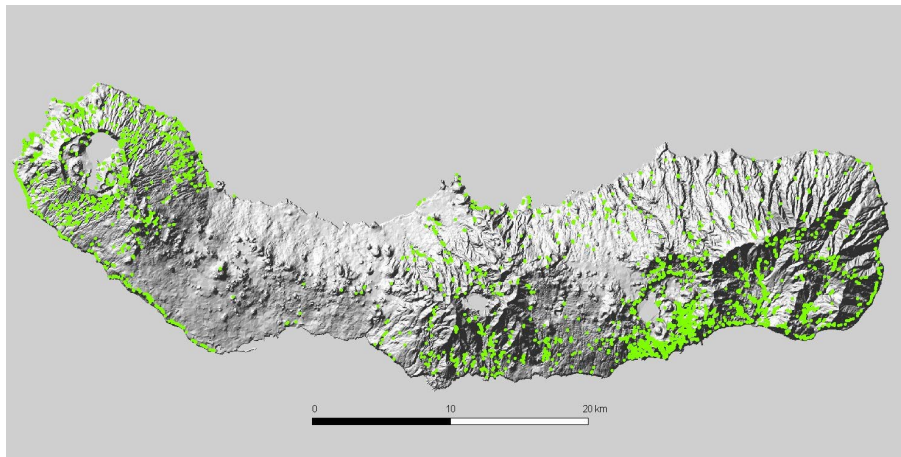
Fig. 4. Landslide Density Map for S. Miguel Island, Azores archipelago. Each green dot represents one landslide. A total of 2818 events are shown.

intervals of occurrence of certain events. All identified landslides (2818 events) were plotted on a topographic map (at 1:25 000 scale) and then were entered into a Geographical Information System (GIS), where each event, represented by a dot, has an associated information sheet. A Landslide Density Map produced using this tool (Fig. 4) helps explain hazard and risk assessment.

It is clear, from the analysis of the Landslide Density Map that most landslides are related to the young central volcanoes and sea cliffs in their vicinity. Vertical caldera walls, relatively steep slopes, deep streamlines and several fault scarps characterize these central volcanoes, which are covered by unconsolidated pyroclastic deposits from recent explosive eruptions. The old basaltic volcanic complex of Nordeste, marked by deep gullies developed on thick sequences of lava flows, some of them very altered, also has a high number of landslides.

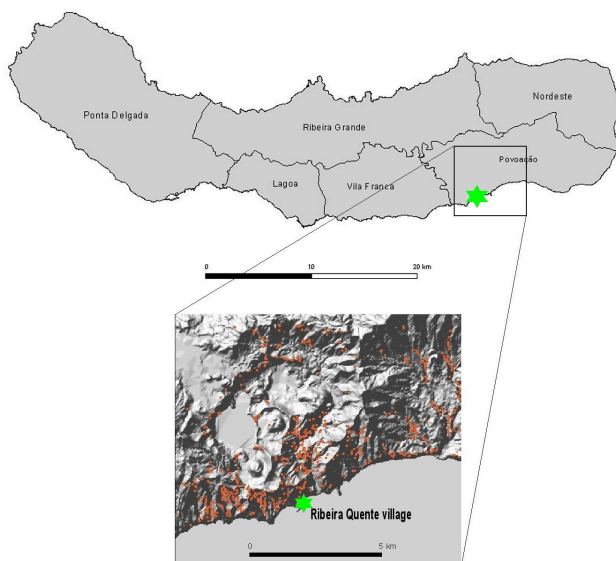
Fig. 5. Landslide density map for the landslides occurred in 31st October 1997, at Povoação county. The green star represents the location of Ribeira Quente village.

On 31 October 1997, nearly 1000 landslides occurred on S. Miguel Island, a few of them killing 29 people who were living in the Ribeira Quente village (Fig. 5). Povoação and Nordeste counties were particularly affected during this event (Gaspar et al., 1997; Gaspar and Guest, 1998). Several houses and bridges were partially or totally destroyed, communications, transportation and the energy supply system were disrupted and areas of fertile land became covered by mud (Fig. 6). Ribeira Quente village was isolated for more than 12 h (Fig. 7).

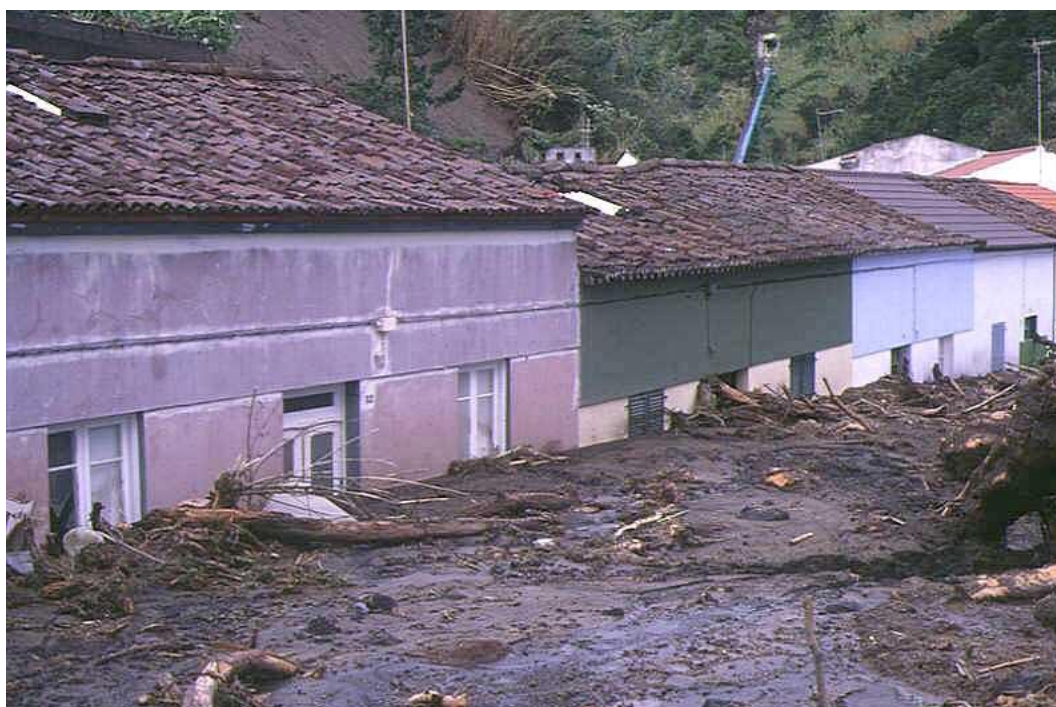
Fig. 6. Houses affected by debris flows during the 1997 Ribeira Quente event.

Most of the landslides were essentially very fluid debris flows, consisting of a mixture of water, pumice and ash. Trees with their root systems, tree trunks and branches were included in most deposits. Depending on the source, some debris flows included large blocks of lava.

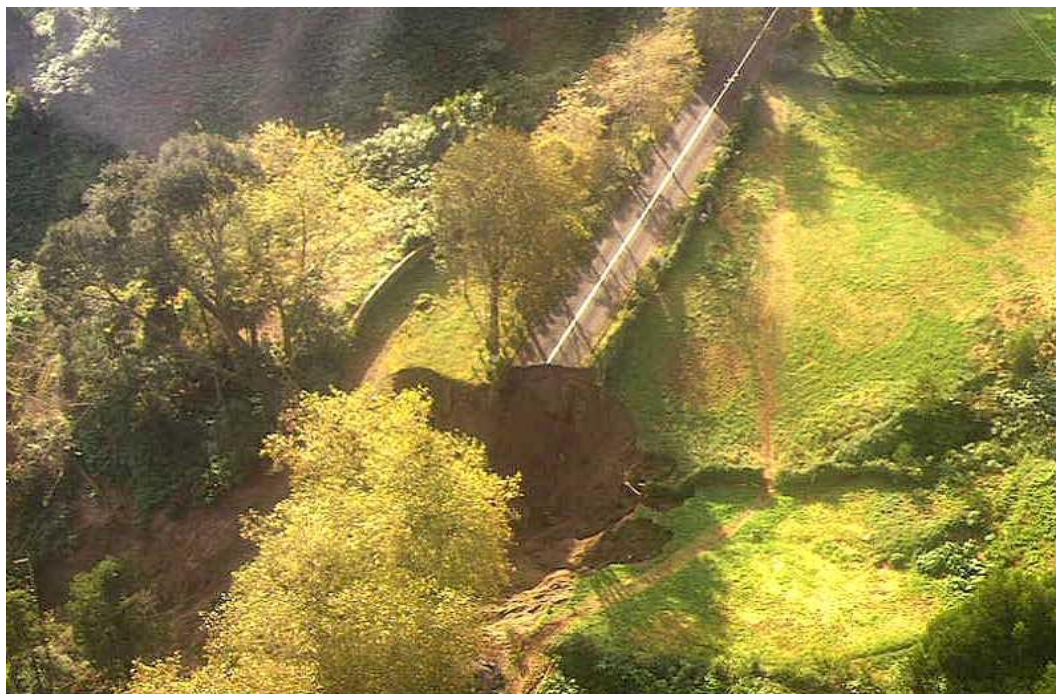
Fig. 7. Road cut by the collapse of the edge of a streamline at Furnas Volcano, during the 1997 Ribeira Quente event.

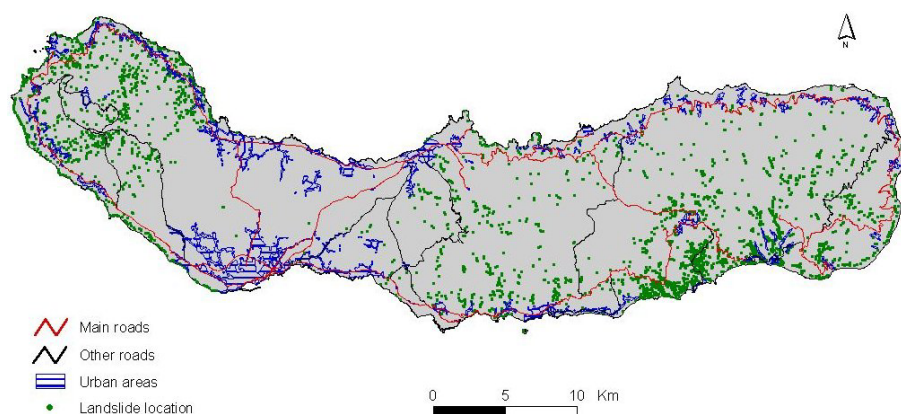
Fig. 8. Landslide Risk Map for S. Miguel Island, Azores archipelago.

The superimposition of the main cities, villages and basic infrastructures of S. Miguel on the Landslides Density Map

emphasizes the high risk that exists in certain areas of the island (Fig. 8). Emergency and land use planning are needed in order to minimize the impact of future complex/multiple events. Authorities should be aware of the importance of hazard and vulnerability assessment to ensure the normal socio economic development of the region.
